DESIGN AND EVALUATION OF ACRYLIC-BASED GROUTS FOR EARTHEN PLASTERS

Kecia Lee Fong

A THESIS

Historic Preservation

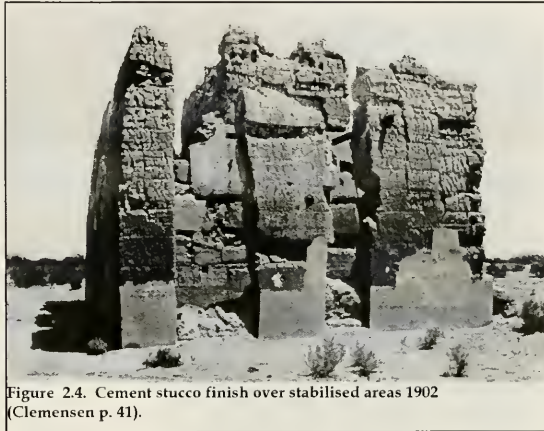
Figure 2.4. Cement stucco finish over stabilised areas 1902 (Clemensen p. 41).

In 1890 Cosmos Mindeleff implemented his recommendations for structural stabilisation. He underpinned areas of the exterior south and east walls with brick and cement mortar which was then faced with a cementitious stucco, installed lateral bracing of metal rod and wood from the south wall to the

He decided that no more brick or concrete should be used on the ruins as Pinkley had proposed, instead any restoration work should be done with as much original material as possible. He had Pinkley make a mixture from the debris and apply it to seal cracks to see how it worked. Holsinger pronounced the effort a success. Holsinger also indicated a source for future repair material. He wrote that Pinkley had recently dug a forty-five-foot-deep well. At the seven-or eight-foot level, he had encountered a stratum of cemented gravel which was identical with the original construction material. That soil could be used for repairs.¹¹

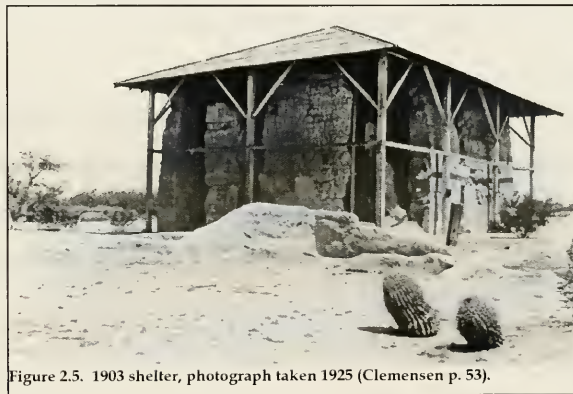
Figure 2.5. 1903 shelter, photograph taken 1925 (Clemensen p. 53).

The first shelter was erected in 1903, as designed first by Mindeleff, to help protect the structure from further rain damage. The second roof shelter was erected in 1932 as designed by Frederick Law Olmsted Jr. By altering the physical environment immediately surrounding the structure the shelters mediated the forces of weather-based deterioration; an early form of preventative, structurally non-invasive conservation.

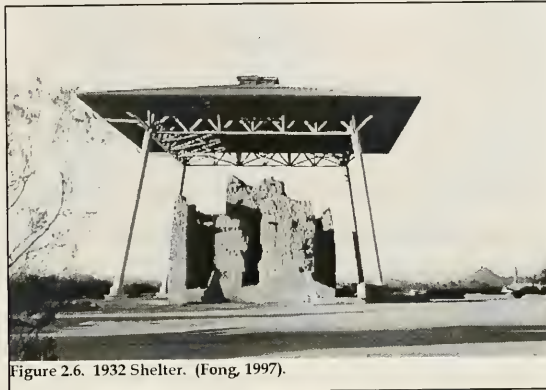
Figure 2.6. 1932 Shelter. (Fong, 1997).

While the shelter has largely removed the problem of direct weathering from rain, it has also visually changed the entire site and its construction has created a microclimate around the ruin that has inadvertently caused some negative impact in its attraction toward birds and other animals.

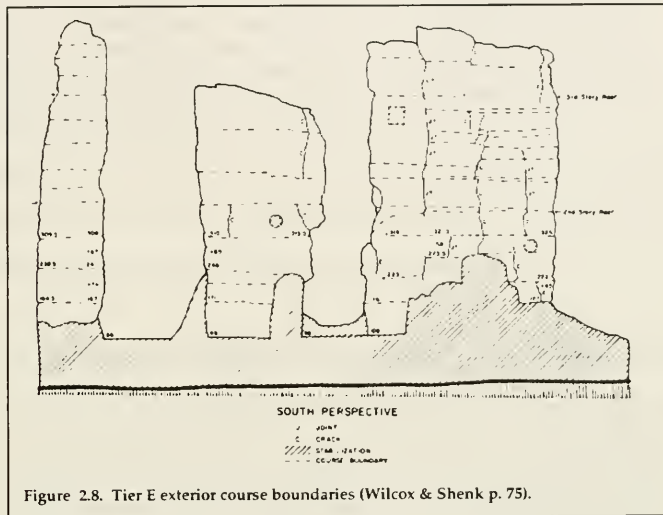
Figure 2.8. Tier E exterior course boundaries (Wilcox & Shenk p. 75).

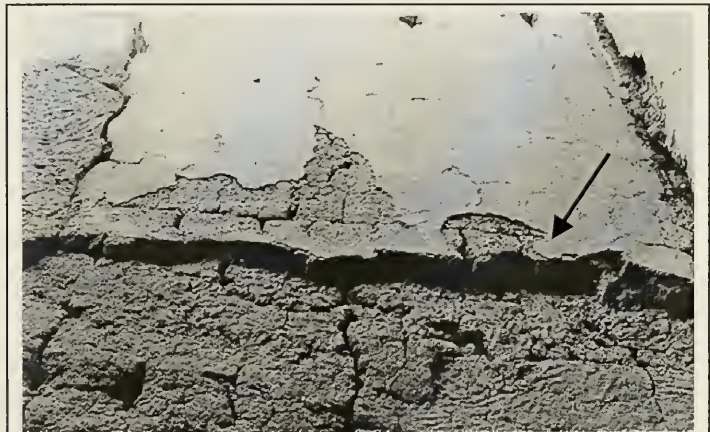
Figure 2.9. Tier B interior, wall finishes layer structure (Fong, 1997).

The exterior of the Casa Grande reveals exposed caliche substrate. There is no apparent vertical planar layer construction to the exterior facade. The interior spaces of the structure are finished with one to three layers of surface finish comprised of 'intermediary' (leveling) and 'finish' layers. The intermediary layers can number between one and two. As the layers progress outward from the wall substrate towards the surface their aggregate size decreases. This is also reflected in the layer thickness. The final finish layer is always the thinnest and

The finish layer is a largely intact continuous plane of caliche plaster with good internal cohesion. Unlike the smooth, polished surface of the finish layer, the intermediary layer is slightly uneven and rough, useful as a key to the final finish coat. This study focuses on the outermost 1.5 cm of finish (average thickness of samples) with special attention paid to the final 0.16 cm finish layer - as observed in the field - for material characterisation and conservation treatment however, it considers the whole planar construction system as a fundamental factor in understanding the causes of detachment. The final surface finish is a monochromatic pink/reddish wash. The colored wash is not considered to be part of the wall layer construction but applied separately in some cases as several discreet layers, probably over time.

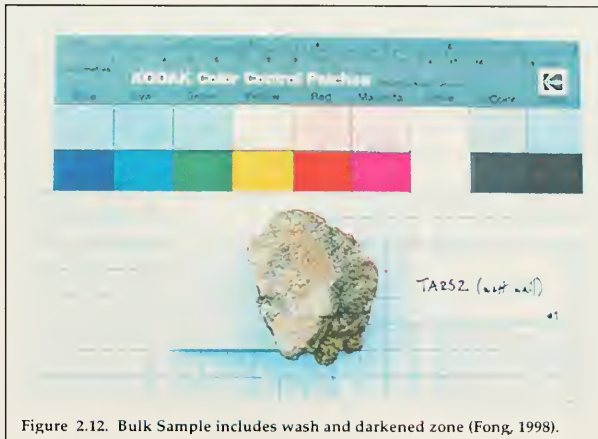
Figure 2.12. Bulk Sample includes wash and darkened zone (Fong, 1998).

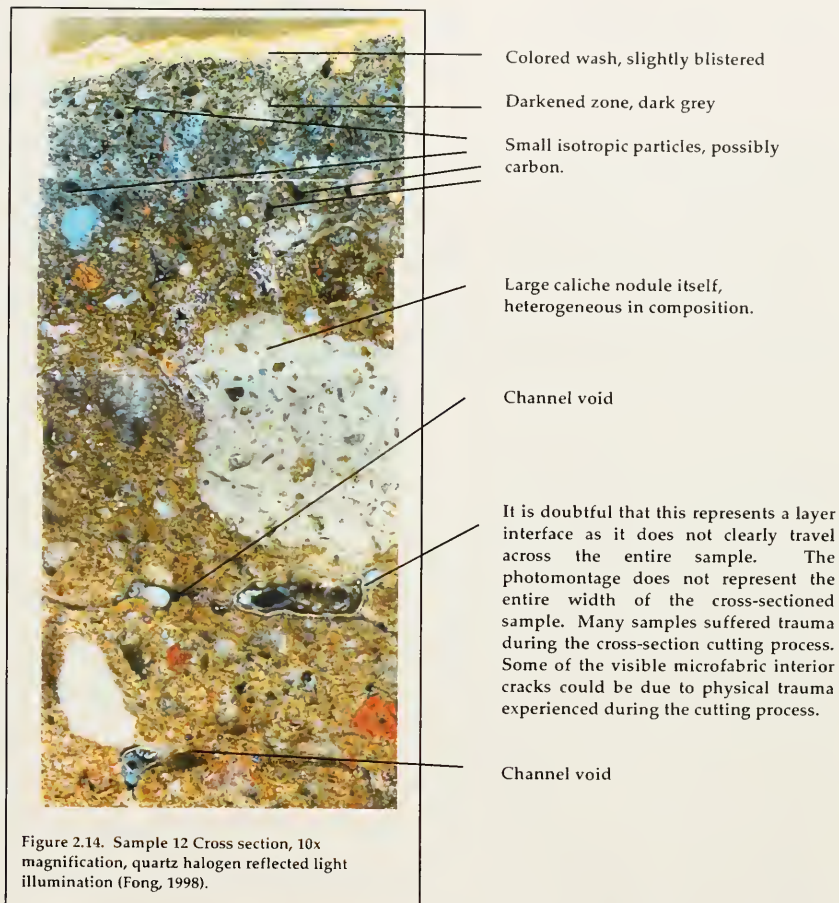
Table 2.1

As viewed in cross section, the micromorphological structure of the finish layer is comprised of heterogeneous aggregates of various shapes and sizes, unevenly distributed throughout the fabric. The wash is clearly a

very thin applied layer. The darkened zone is not a specific layer but rather an intrinsic coloration within the finish layer.

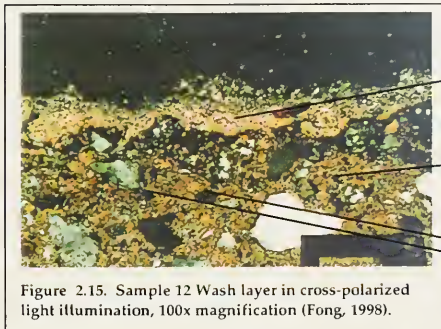
Figure 2.15. Sample 12 Wash layer in cross-polarized light illumination, 100x magnification (Fong, 1998).

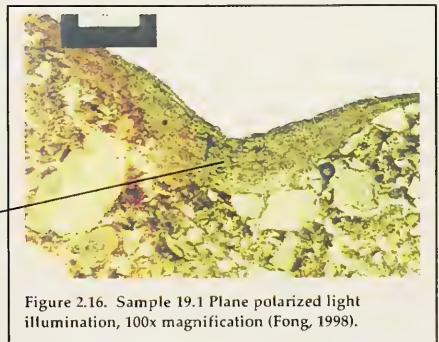
Applied wash collected in divot of surface. There is some suggestion of stratification of wash layers

Figure 2.16. Sample 19.1 Plane polarized light illumination, 100x magnification (Fong, 1998).

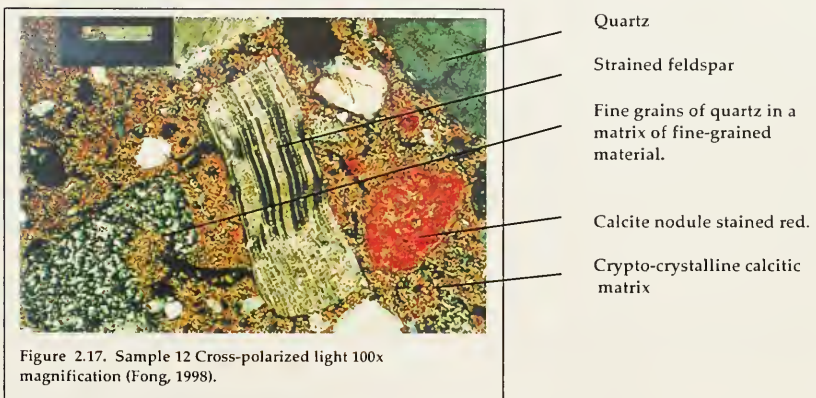
The primary aggregates of all samples are quartz, feldspar and calcite nodules. Alazarin red staining reveals a low to moderate presence of calcite in the fabric matrix. The calcite is otherwise concentrated in caliche nodules found as aggregates within the matrix (see Figure 2.15 and 2.16). The wash layer is not high in calcite as it did not retain the stain. It is

composed of extremely fine particles, possibly composed of mineralogical clays (see Figures 2.13 and 2.14).

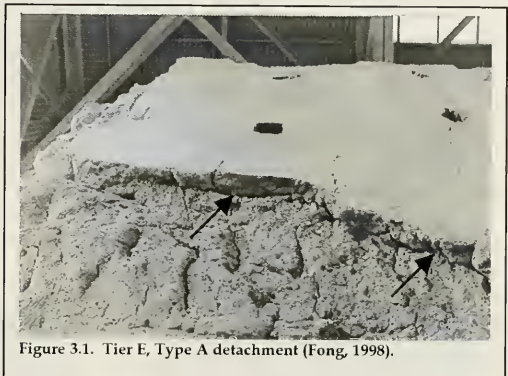
Figure 3.1. Tier E, Type A detachment (Fong, 1998).

Two types of surface finish detachment conditions are in evidence at the Casa Grande herein identified as Type A and Type B. Type A (large scale) is the more pervasive detachment condition of the two and found throughout the structure. It is characterised by a fairly continuous plane of detachment measuring an average of 3 - 5 mm between two fairly even, continuous adherend surface planes (intralayer or finish layer to substrate). Layer thickness ranges from 0.16 - 0.6 cm (1/16 - 1/4 inch) for finish to 0.6 - 10 cm (1/16 - 4 inches) for intermediary (see Figures 3.1 and 3.2). The condition appears to be relatively stable (inactive). Type B (small

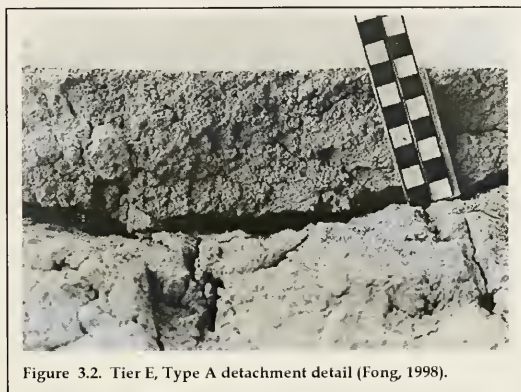
Figure 3.2. Tier E, Type A detachment detail (Fong, 1998).

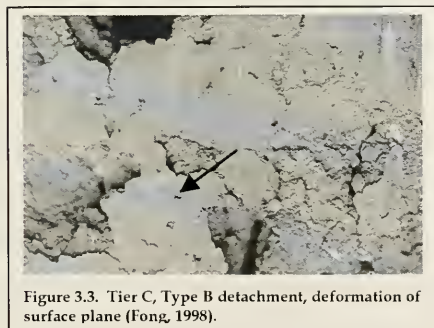
Figure 3.3. Tier C, Type B detachment, deformation of surface plane (Fong, 1998).

scale/flaking) is the less common detachment condition and is recognized by an actual deformation in the outermost finish layer. It is frequently found in conjunction with cracking and is easily exacerbated by animal activity and debris accumulation. This condition primarily occurs on a small, localised scale (see Figures 3.3 and 3.4). This type of detachment is the more critical of the two as the now deformed fragment hangs in an unstable, precarious state. This instability characterises this condition as active.

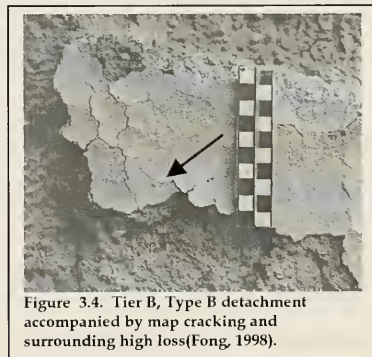
Figure 3.4. Tier B, Type B detachment accompanied by map cracking and surrounding high loss(Fong, 1998).

discernible through associated surface conditions such as mapcracking, deformation and surrounding areas of high loss.

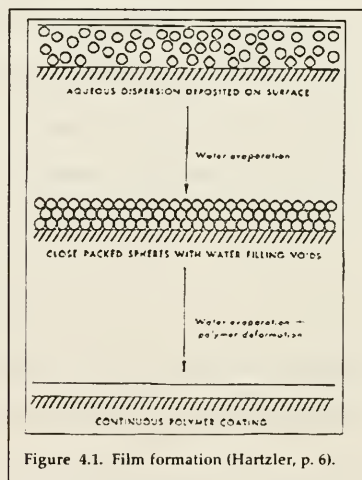
Figure 4.1. Film formation (Hartzler, p. 6).

Brownian motion is "the continuous zigzag motion of the particles in a colloidal suspension. The motion is caused by impact of the molecules of the liquid upon the colloidal particles."⁴ This constant motion keeps the particles in suspension and prevents them from flocculating or coagulating. Emulsions are able to carry a high solids content in a relatively fluid form, up to 70%, and can be held in a stable suspension at very low viscosities compared with equivalent polymer solutions.⁵

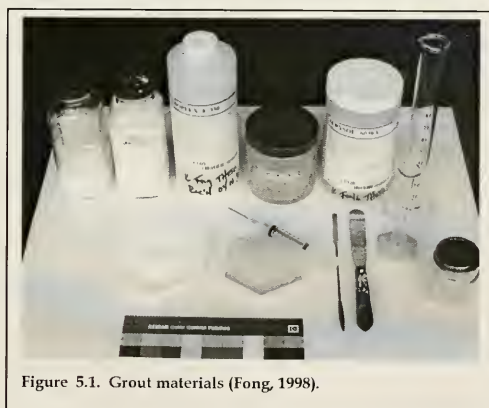
Figure 5.1. Grout materials (Fong, 1998).

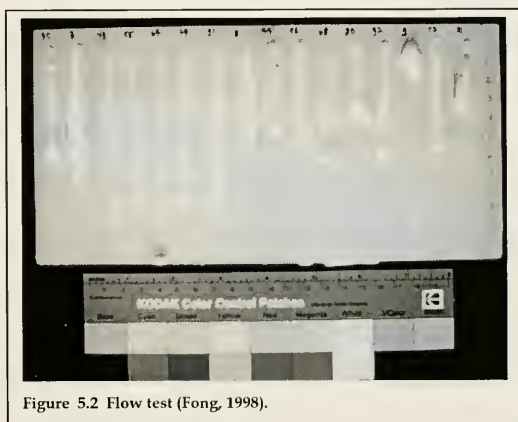
Figure 5.2 Flow test (Fong, 1998).

Twenty cc of liquid was measured into a small glass container. In a separate, dry container fillers were measured, combined and then added to the liquid. The jar was vigorously shaken

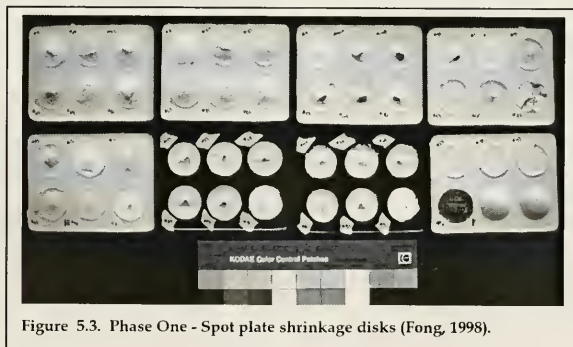
Figure 5.3. Phase One - Spot plate shrinkage disks (Fong, 1998).

Grout preparation and injection procedure was the same for all tests. 4 cc were extruded into individual spot wells, excess was screed with an even edge, and disks were allowed to air dry set in the laboratory.

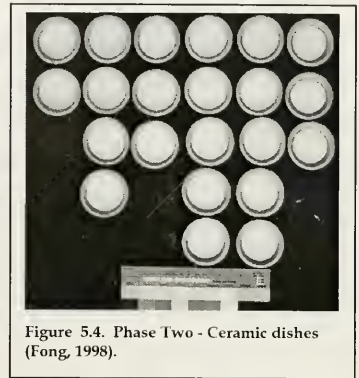
Terra cotta saucers were soaked overnight in water to prevent rapid drying of emulsion mixtures into the porous molds. Saucers were hand dried with paper towels. 10 cc were injected into the individually labeled ceramic saucers and allowed to air dry cure in the laboratory.

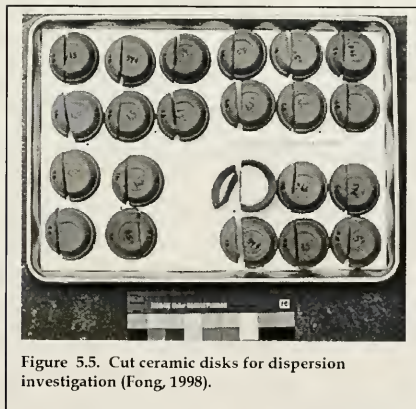
internal cohesion and porosity. A cross section of each phase two shrinkage test sample was cut for qualitative analysis. Samples were cut with a diamond edged masonry circular saw blade, sanded, and trimmed. All samples were inspected visually and with a Nikon SMZ-U under quartz halogen reflected light illumination at 10x magnification.

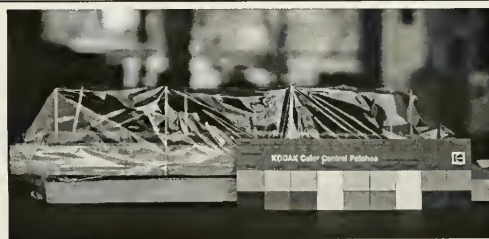
Figure 5.7 Strength test block fabrication, tented in molds (Fong, 1998).

a plastic spatula, the board was tamped to release air from the blocks, and the excess was screed from the tops of the blocks. Molds were tented with plastic wrap for two days at which point a straw was inserted into the center of half of the blocks to create an injection port hole for the grout formula application. Molds were removed after two days or once blocks had shrunk sufficiently to retract from molds, whichever came first. Blocks remained tented for another two days. Blocks were turned over and relocated on the board to dry areas and the plastic wrap was removed. Blocks were air cured in the laboratory until dry (average May laboratory temperature was 28° C, average relative humidity (RH) was 60).

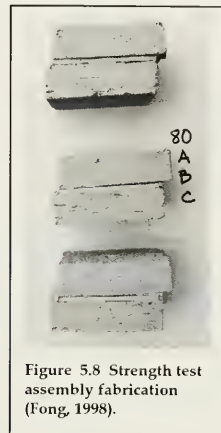
Figure 5.8 Strength test assembly fabrication (Fong, 1998).

Assemblies were fabricated based on guidelines provided in ASTM D3931. Three assemblies were made per formula (A, B, C) plus one additional for machine calibration for a total of 19

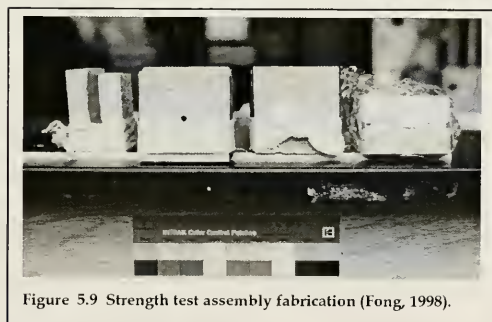
Figure 5.9 Strength test assembly fabrication (Fong, 1998).

Once the prewetting stage was complete, the grout mixture was injected through the port hole with a hypodermic needle and syringe. Cotton was held around needle and porthole to block reverse airflow while the grout was slowly injected into gap. The needle was periodically turned to shift flow direction given its bias cut. The opening at the top of the assembly allowed visual access to grout flow within the gap. Once the gap was filled or ceased to receive grout, the excess was screed from the top edge, the assembly was wrapped in plastic

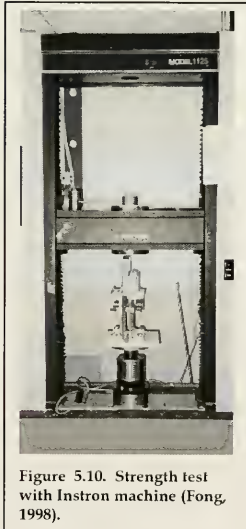
Figure 5.10. Strength test with Instron machine (Fong, 1998).

Radin at the Laboratory for Research on the Structure of Matter (LRSM) at the University of Pennsylvania. Tests were performed with an Instron Testing Machine Model 1125 with a cross head speed of 0.1 inches per minute and a chart speed of 5 inches per minute. The machine was calibrated to accommodate the form and characteristics of the assemblies,

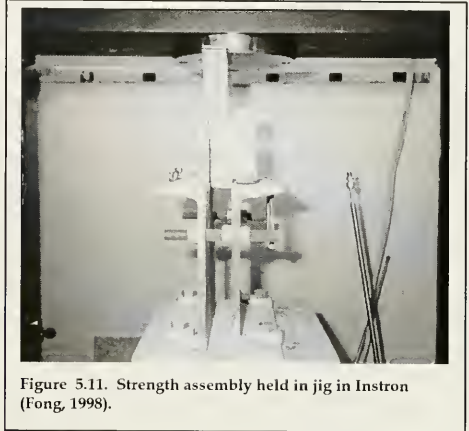
Figure 5.11. Strength assembly held in jig in Instron (Fong, 1998).

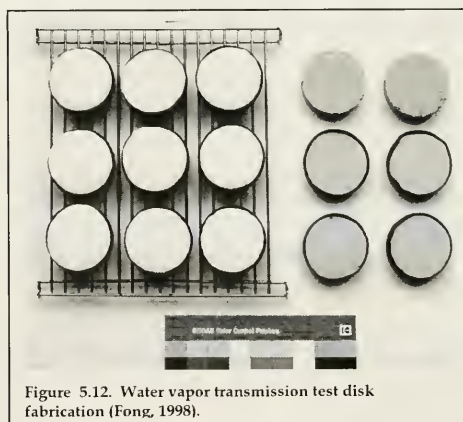
Figure 5.12. Water vapor transmission test disk fabrication (Fong, 1998).

The caliche preparation was identical to preparation in the shear strength assembly fabrication (see 5.4 Shear Strength Under Compressive Force). A total of 19 disks were fabricated from the original wall loss fragment to test six grout formulations; three disks per formulation and one untreated control. PVC pipe section molds produced disks with 6.7 cm diameter, 2 cm thickness and 35.27 cm² surface area. Once dry, the exterior edge was wrapped in electrical tape. The tape extended 3 mm above the smooth face of the disk to serve as a retaining wall for the 3 mm film layer later to be applied. Disks were prewet with 6-7 cc, up to the fill line, of 10% concentration of E-330. Once absorbed, 12 cc of grout were injected onto each disk to form a 3 mm layer. Disks were set aside to air set for one week.

Disks were sealed in the openings of 250 ml beakers each containing 140 ml of deionized H₂O and placed in a closed glass chamber containing calcium sulfate desiccant. The chamber and desiccant were monitored to create an environment of a relative stable humidity as defined by ASTM E96. Assemblies were removed from the chamber and weighed and their positions

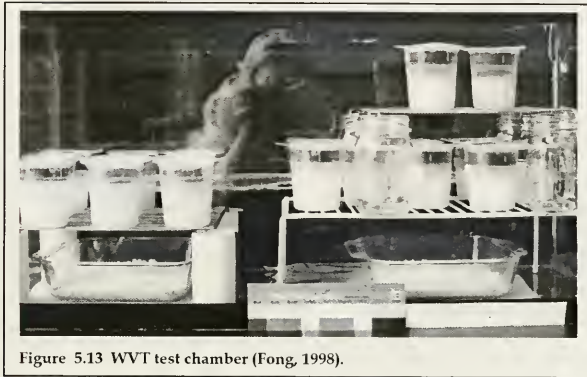
rotated within the chamber once every 24 hour cycle. The test was run over a period of 17 days to insure a steady state of weight loss was achieved.

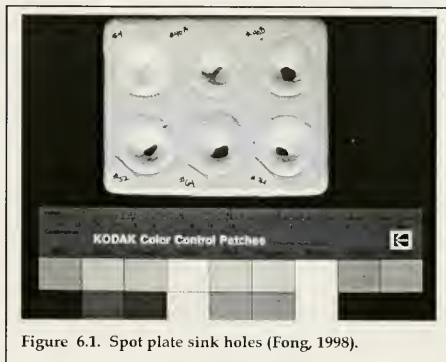
Figure 6.1. Spot plate sink holes (Fong, 1998).

surface combined with its curved concave well shape affected the process of evaporation. In the process of setting, the water evaporated most rapidly generally from the top and shallow perimeter of the well while the thickest center section retained liquid for the longest amount of time resulting in an uneven set. For this reason a second series of shrinkage tests was proposed using porous, flat-bottomed molds (Phase two).

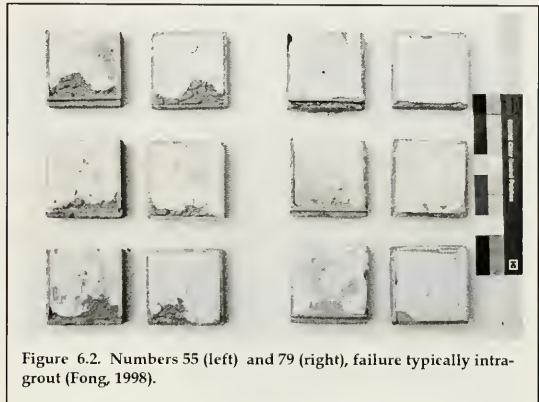
Failure within numbers 55 and 79 typically occurred within the grout. The low occurrence of adherend/grout interfacial failure indicated successful preinjection procedure, sufficient penetration, and good adhesive bond strength.

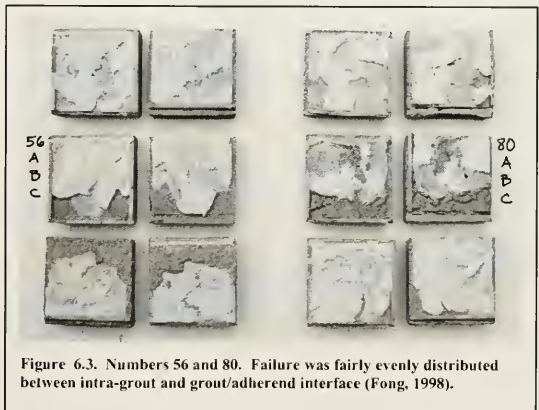
40% - Nos. 56 and 80

Failure within numbers 56 and 80 occurred both within the grout and at the grout/adherend interface. The plane of failure was never continuous within an assembly. Point of failure frequency (intra grout or at interface) was nearly equally divided.

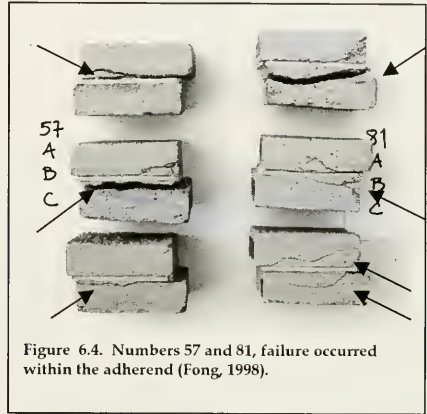
Neat - Nos. 57 and 81

Failure typically occurred within the adherend. Failure within the adherend does not meet the criterion of sufficient strength. In this instance, the cohesive and bond strength of the grout exceeded the cohesive strength of the adherend. Failure within the adherend is not acceptable as the end-goal is the preservation of the original fabric. Excessive strength in an adhesive results in

destruction of surrounding fabric as the exerting stress is transferred to the weakest point. Distribution (coverage) of the grout throughout the gap decreased from the 20% and 40% formulae (55, 79, 56 and 80). Incomplete coverage was suspected based on injection difficulty experienced during fabrication. It is useful to note that even with incomplete coverage, formulae nos. 57 and 81 still offered the greatest strength. Formulae nos. 57 and 81 were eliminated for their excessive strength.

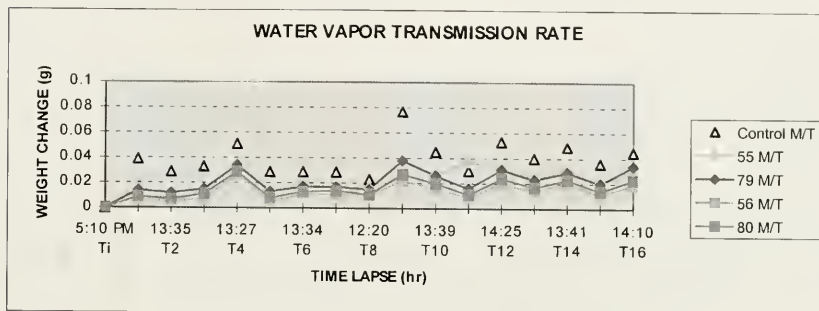
Table 6.7 reveals that the steady state exists between T6 and T7. The fluctuations in weight loss that occur after the steady state are attributable to desiccant change. In an effort to control the RH within the chamber the desiccant was changed at T9, T12, T14 and T16. However, the effect of this action was a seemingly erratic sequence of difference in $\Delta M / \Delta t$.

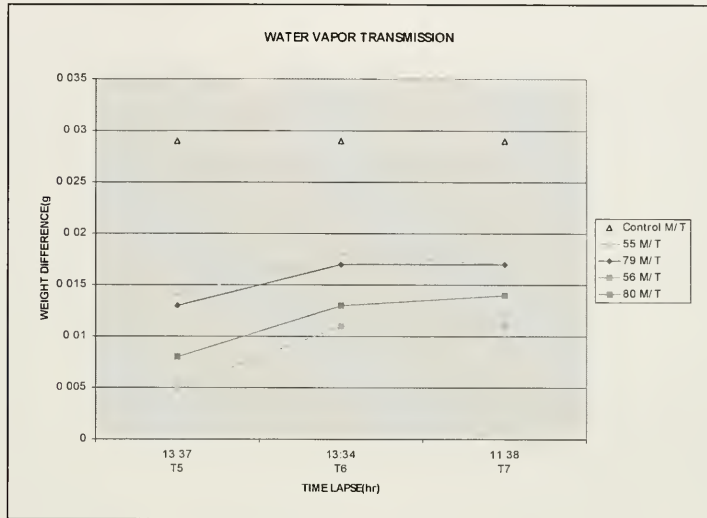
Table 6.8

WVT at T6 =

$$0.018 / .003527 \text{ m}^2 = 5.103 \text{ g/h}\cdot\text{m}^2$$

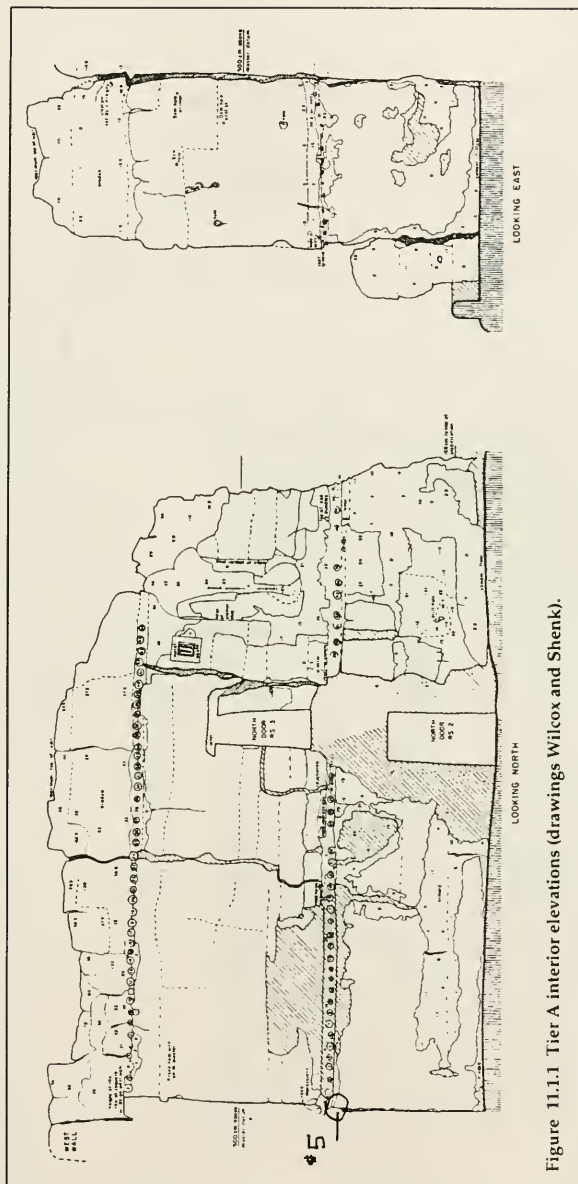
Figure 11.1.1 Tier A interior elevations (drawings Wilcox and Shenk).

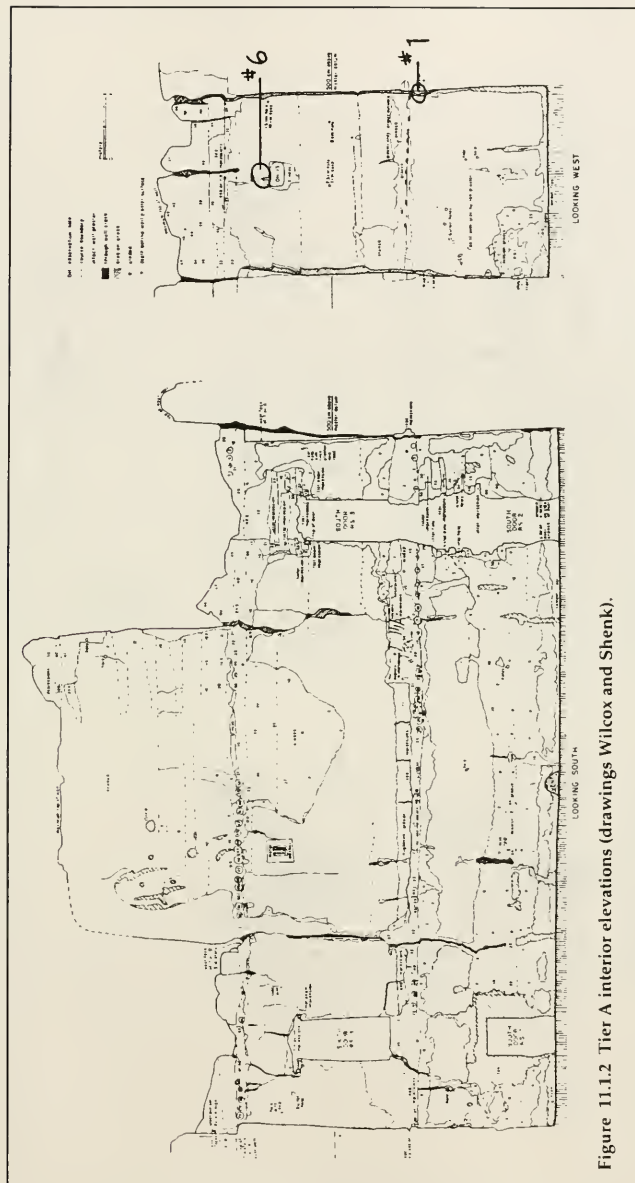
Figure 11.1.2 Tier A interior elevations (drawings Wilcox and Shenk).

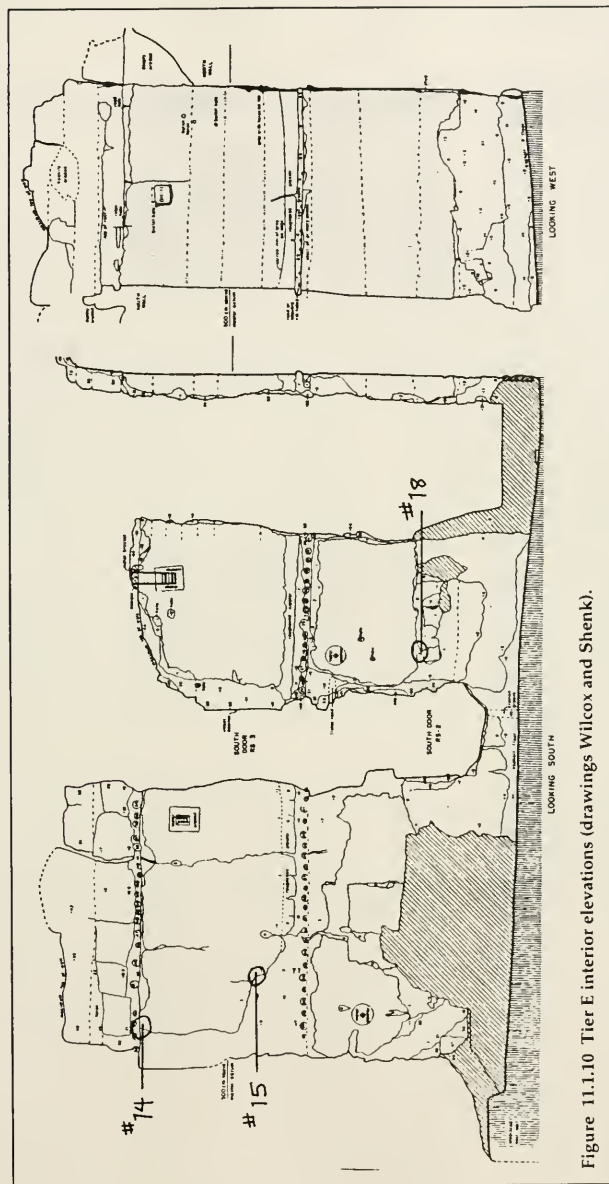
Figure 11.1.10 Tier E interior elevations (drawings Wilcox and Shenk).

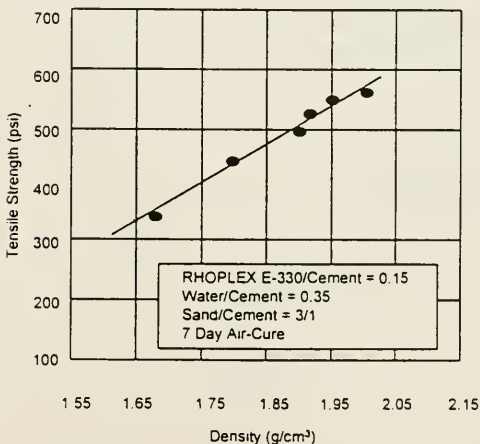
TENSILE STRENGTH vs DENSITY

important to minimize the air entrainment due to foaming. By using an appropriate amount of antifoamer it is possible to get high density, polymer-modified mortars with excellent strength properties. In general, the wet density of a latex-modified cement mortar should be at least the same as unmodified mortar. In most cases the wet density will be 2.0 g/cm³ or higher.

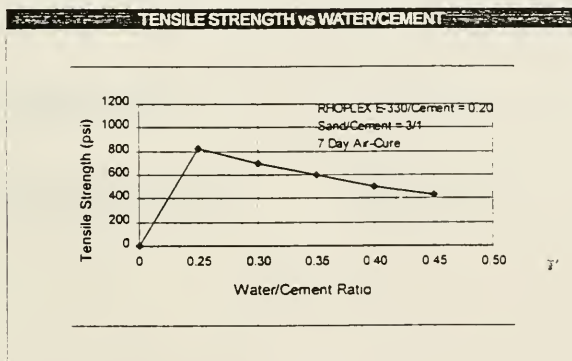
The effect of the water/cement ratio on tensile strength at a constant polymer level is shown in the graph below.
